Water infiltration through openings in a vertical plane under static boundary conditions

Nathan Van Den Bossche¹, Michael Lacasse², Travis Moore², and Arnold Janssens¹

¹*Department of Architecture and Urban Planning, Ghent University, Ghent, Belgium*

²*Institute for Research in Construction, National Research Council, Ottawa, Canada*

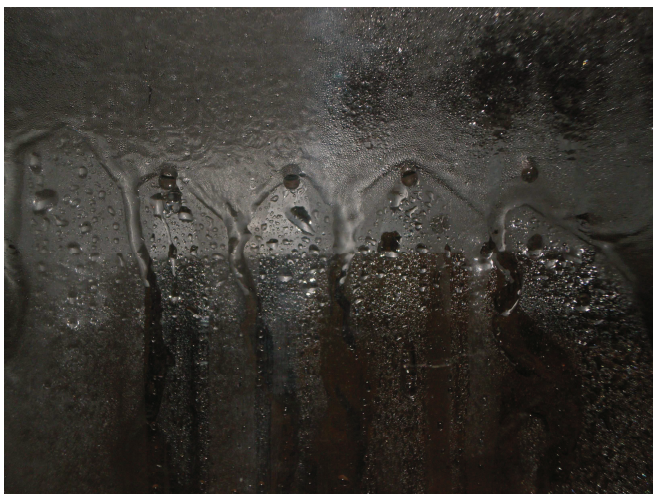
Fig. 3. Diagonal rivulets at the top of the deficiencies

The uniform film changed into rivulets at the deficiencies by forming diagonal rivulets that delimit the film runoff. The water flow at these outer boundaries is significant, whereas the water flow in between these rivulets is very shallow and in terms of flow rates less important than the rivulet (Mertens et al., 2004). Three different modes were recorded: the diagonal rivulet was typically located at the top or bottom edge of the deficiencies (figures 3 and 4 respectively), but sometimes the rivulet formation occurred below the deficiencies (figure 5). In the cases that rivulets were formed above the deficiencies, the test was stopped and repeated after cleaning the surface. These runoff patterns were typically stable for a period between 30s and 15min, but then shifted to another mode as described above. This indicates that the flow rate of the water stream lies above the dynamic flow threshold (Le Grand-Piteira et al., 2006). When the inertia of the water flow in the rivulet supersedes the pinning forces at the border the flow pattern becomes unstable and a new equilibrium is found in a different location where the pinning forces again supersede the inertia of the flow.

The measurements showed that diagonal rivulets were formed in the runoff pattern on the exterior side, located at the top, bottom or below the deficiencies. These patterns shifted during testing, altering the condition of the exterior side of the deficiency. If the rivulets were formed at the top of the hole, no water was present and the water inside the deficiency was thus subjected to an outwards oriented capillary force, whereas the cohesive forces of the rivulet are pulling the water inwards. When the capillary forces are stronger, the water will stay in the deficiency and the rivulet is stopped. It is unclear to what degree the infiltration rate affects the shift in runoff pattern on the exterior side. Figure 6 shows how the runoff pattern shifts and the diagonal rivulet moves from the bottom of the deficiency to the top of the deficiency, which corresponds to a shift from figure 4 to figure 3. It should also be noted that intermediate situations (between mode 2 and 3) occurred, and it is unclear to what degree the rivulets at the top of the deficiency were still able to provide sufficient supply.

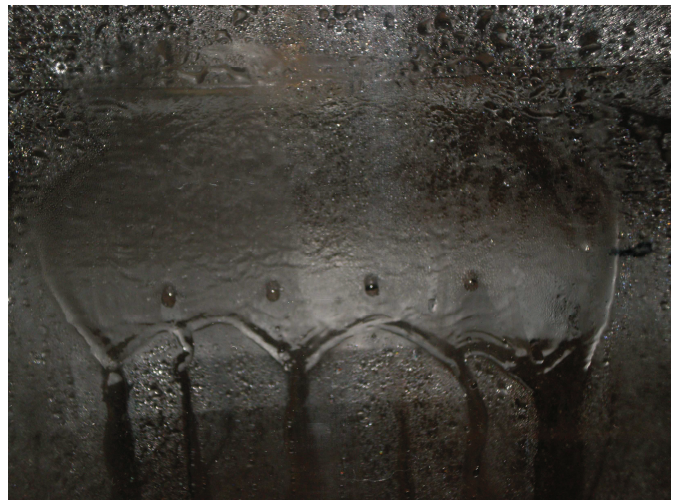
Fig. 5. Uniform film flow over deficiencies and rivulet formation underneath

Although it is assumed that the runoff film introduces a pressure difference on the deficiency, it is unclear how this is affected by the different runoff patterns. Tammes and Vos (1984) claimed to find hydrostatic pressures due to runoff up to 100Pa for brick walls, but no information was provided for other substrates, and the effect of runoff patterns was not discussed. On the other hand, one can question the concept of a hydrostatic water column in a runoff film: perhaps the velocity can be high enough to introduce negative pressures on the deficiency by means of the venture effect. Furthermore, it is even uncertain whether or not water was always present at the exterior side of the deficiency. Figures 3-5 show how the location of the diagonal rivulets on the 4mm Ø deficiencies changes over time: the inertia of the water gradually overcomes the pinning forces at the edge and thus moves the rivulets downwards. However, the runoff pattern sometimes breaks up, introducing rivulets again at the deficiencies.
